Spring Brake Valve

...for the long haul

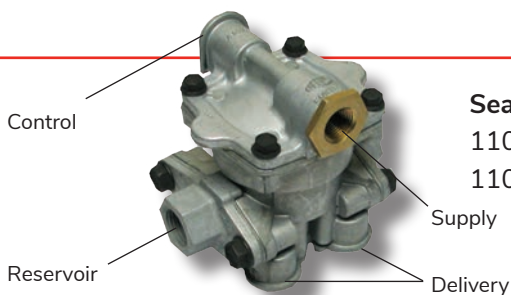
110170
110270

Sealco

All parts 3/8" NPT except reservoir 1/2" NPT
High Temperature version of 110170

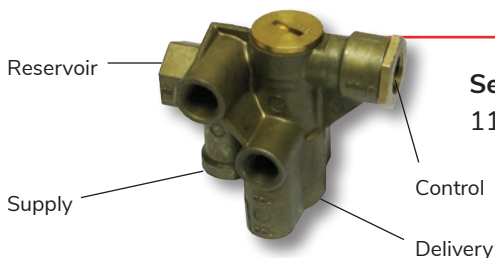
110701

Sealco

Supersedes 110903
All parts 3/8" NPT except reservoir 1/2" NPT

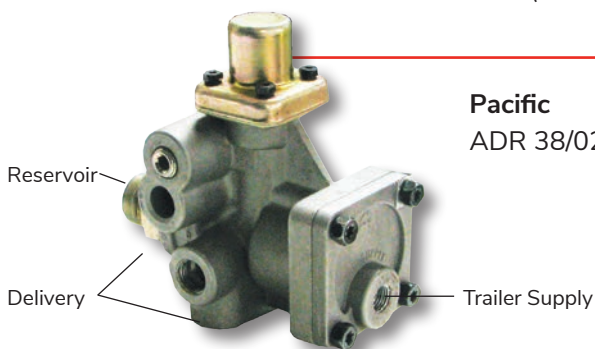
Pacific

ADR 38/02 Reservoir mount 3/4" NPT
Delivery 3/8" NPT
Other ports 1/4" NPT
