SAFETY ALERT

October 2018

SEATBELTS IMPORTED BY BVL (BUSINESS VENTURES LIMITED) AND MANUFACTURED BY CHANGZHOU BWD, CHINA

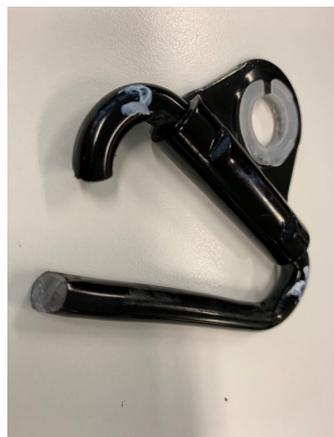
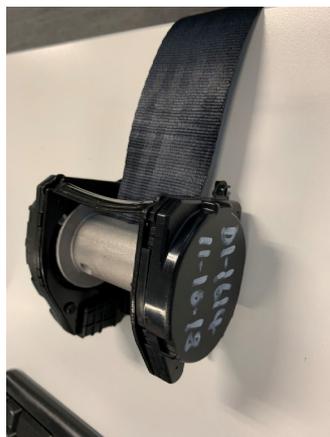
In crash testing, failure occurred in the shoulder anchor point (D-ring) and the retractor mechanism failed to lock and prevent runout of the belt.

The Transport Agency is advising people that if BVL/Changzhou BWD seatbelts are fitted in their vehicle's driver seat that they do not use their vehicle until replacements are fitted. If fitted in other seating positions, the advice is not to allow passengers to use those seats. It has also instructed vehicle inspectors to fail a vehicle for its warrant of fitness (WoF) or certificate of fitness (CoF) inspection if these seatbelts are identified in a vehicle.

- Review your vehicle and determine if your three-point seatbelts have labels that say BVL and Changzhou BWD (as shown above). If in doubt, a vehicle inspector (such as a WoF or CoF inspector) will be able to identify them.
- If these belts are fitted in the driver's seat, our advice is to not use the vehicle until replacements are fitted. If fitted in other seating positions, our advice is to not allow passengers to use those seats.
- Vehicle inspectors have been instructed to fail a vehicle for its WoF or CoF inspection if these seatbelts are identified in your vehicle.
- Feedback regarding BVL seatbelts manufactured by Changzhou BWD or all other enquiries or questions related to this should be directed to the Transport Agency on 0800 699 000.

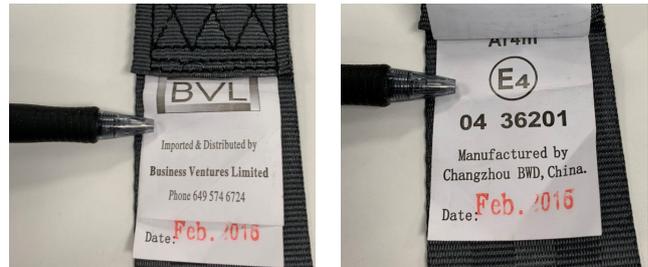
How to identify a BVL/Changzhou BWD seatbelt

The label is located where the outboard strap is attached to the vehicle, typically found between the door and the seat.

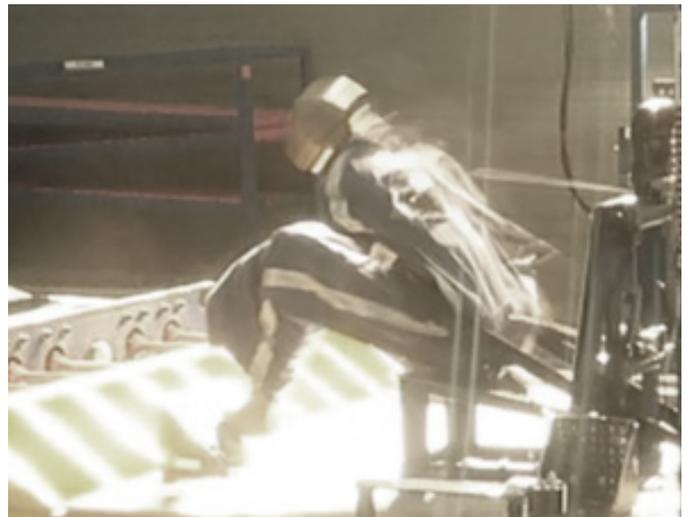
In the 50km/h test, the mannequin becomes unrestrained after the seatbelt fails.
